GRAND-CHARITON BASIN

LAKE THUNDERHEAD DAM
PUTNAM COUNTY, MISSOURI
MO 10007

PHASE 1 INSPECTION REPORT NATIONAL DAM SAFETY PROGRAM

MAY, 1980

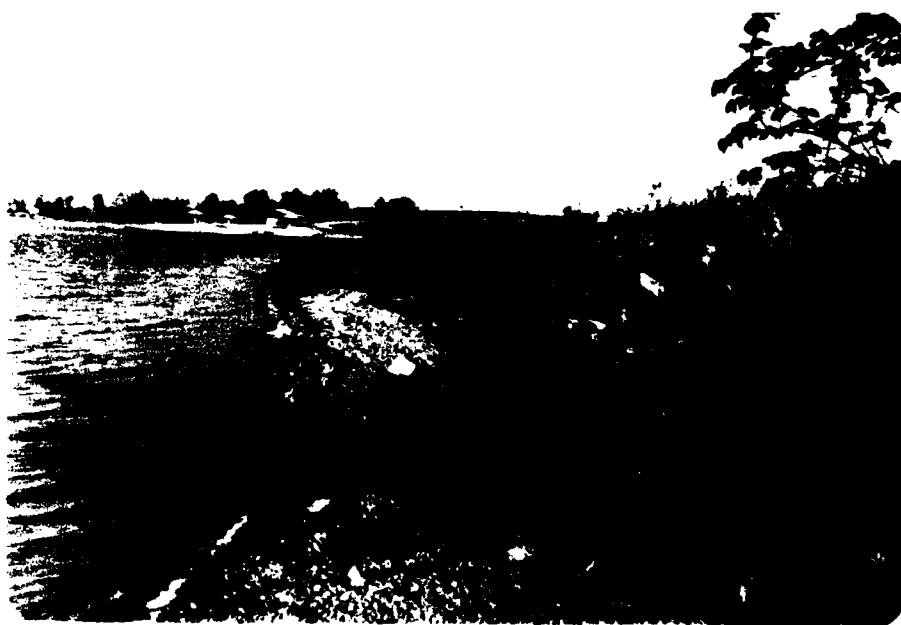
PHOTO NO. 7 - EROSION ON UPSTREAM SLOPE NEAR BEND IN
CENTERLINE ON LEFT END

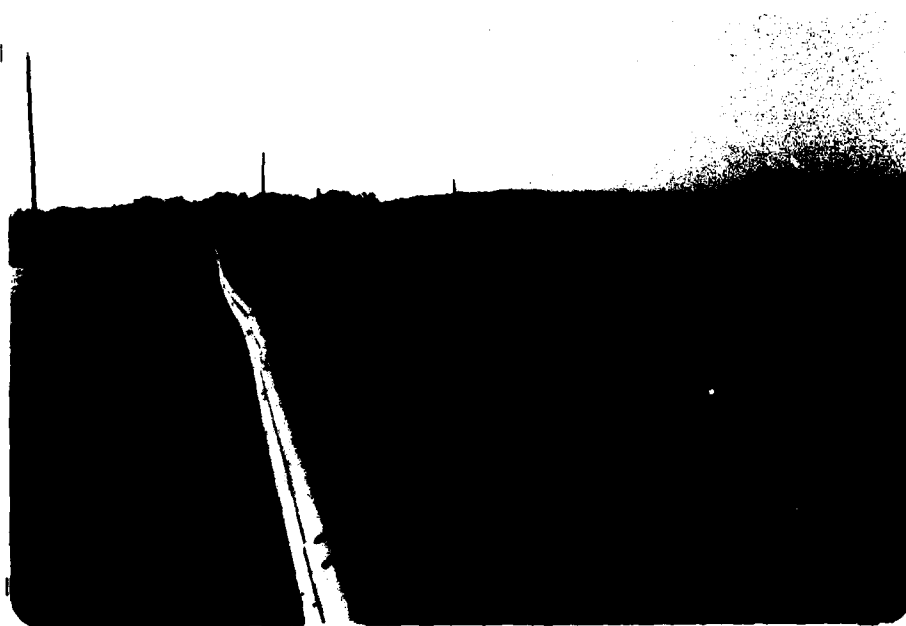
PHOTO NO. 9 - UPSTREAM FACE AND CREST TAKEN FROM LEFT OF
CURVE IN CENTERLINE LOOKING SOUTH

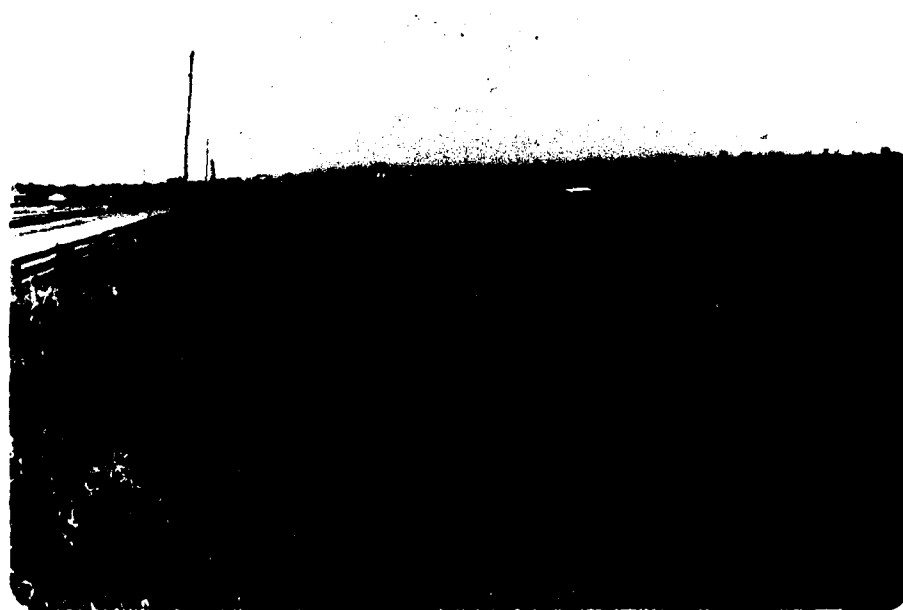
PHOTO NO. 17 - DOWNSTREAM FACE FROM RIGHT END

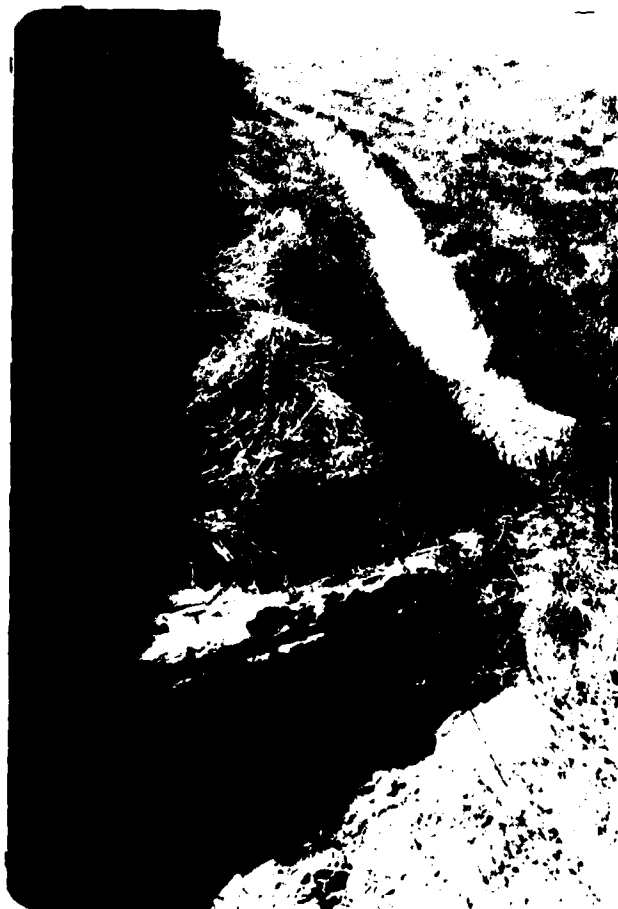
There was no indication of seepage in the abutment troughs. However, there is a headcut about 6 feet deep and a gully in the right abutment trough that extends from the berm to the toe of the dam. The concrete surface drain down the right abutment trough extends only from the top of the dam to the berm and not to the valley floor as shown on the plans. The sewer line which traverses the berm is exposed in the gully head cut in the right abutment trough as shown in Photo No. 18. Photo No. 19 shows the end of the concrete lined ditch and the headcut at the upper end of the gully.

PHOTO NO. 19 - CONCRETE LINED DITCH IN RIGHT ABUTMENT
TROUGH. GULLY BEGINS AT END OF LINED DITCH

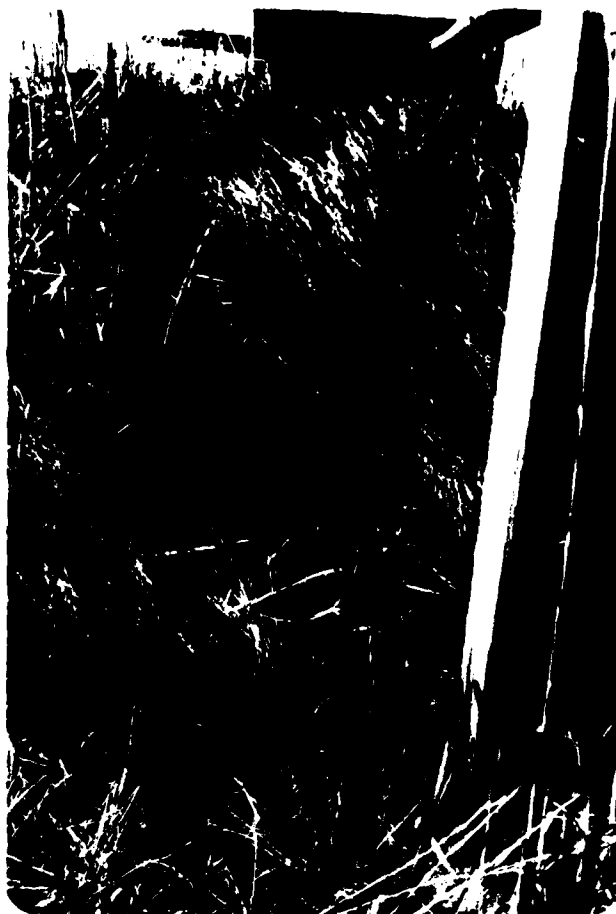
PHOTO NO. 26 - SEEPAGE
DISCHARGE FROM LIFT
STATION AREA. LIFT
STATION IN BACKGROUND

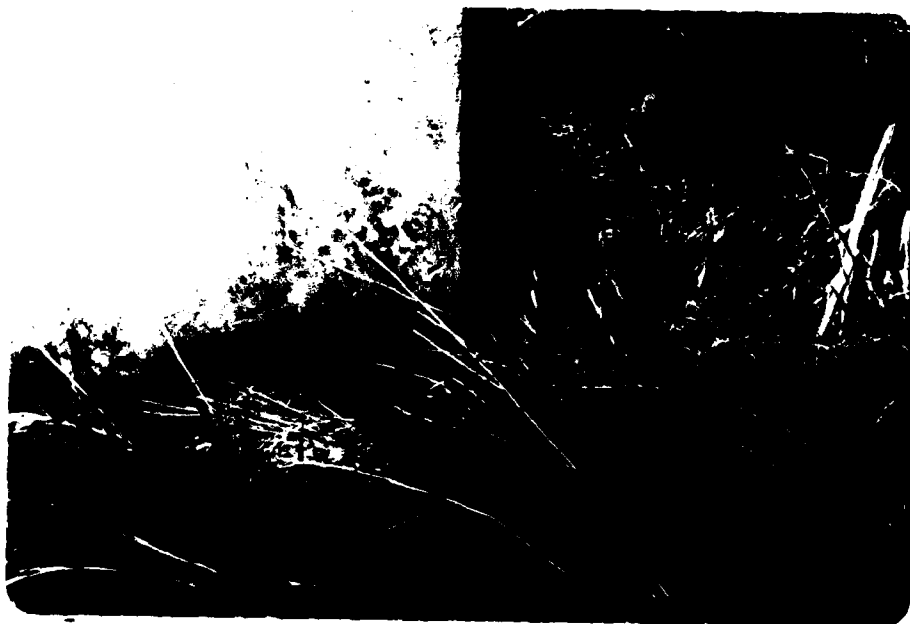
PHOTO NO. 27 - SEEPAGE AROUND UPSTREAM SIDE OF LIFT STATION

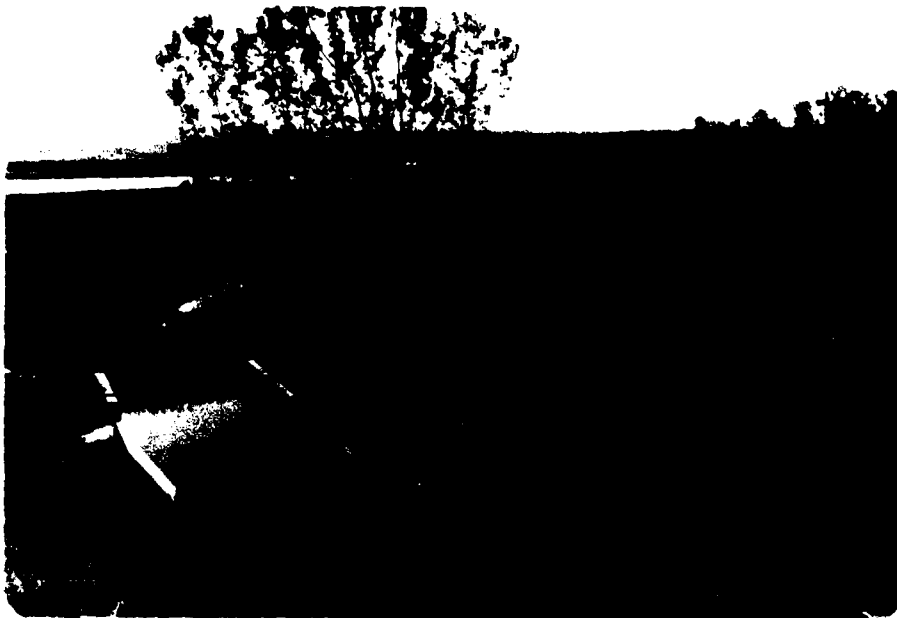
PHOTO NO. 28 - PRINCIPAL SPILLWAY OUTLET WITH LIFT STATION AND
SEWER LINE TO RIGHT

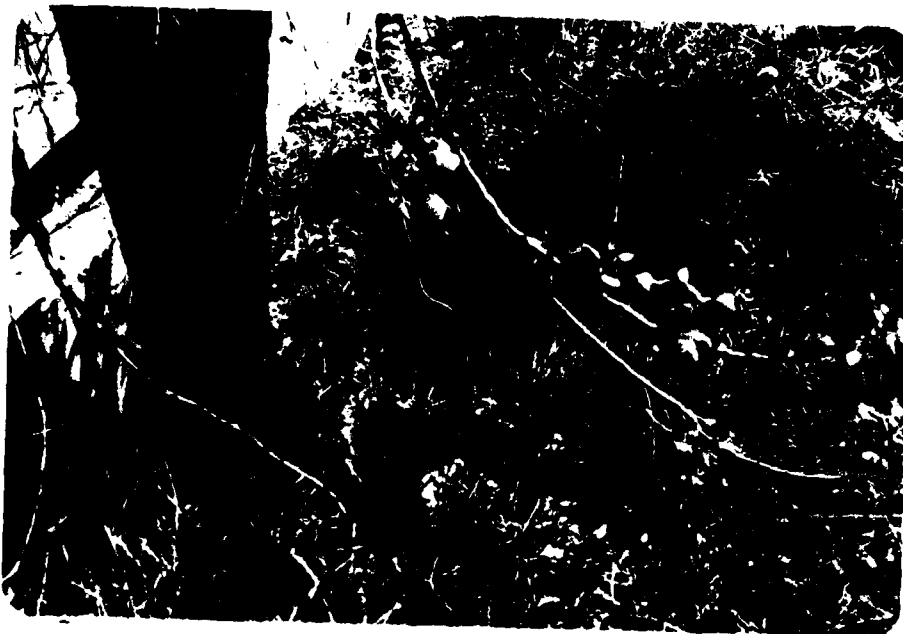
PHOTO NO. 29 - TREE AND RODENT HOLE AT RIGHT SIDE OF SPILLWAY
CHUTE

- (9) The rodent hole along the right wall of the principal spill-way outlet should be repaired.
- (10) A program of periodic inspection and maintenance should be initiated in order to protect the integrity of the dam.

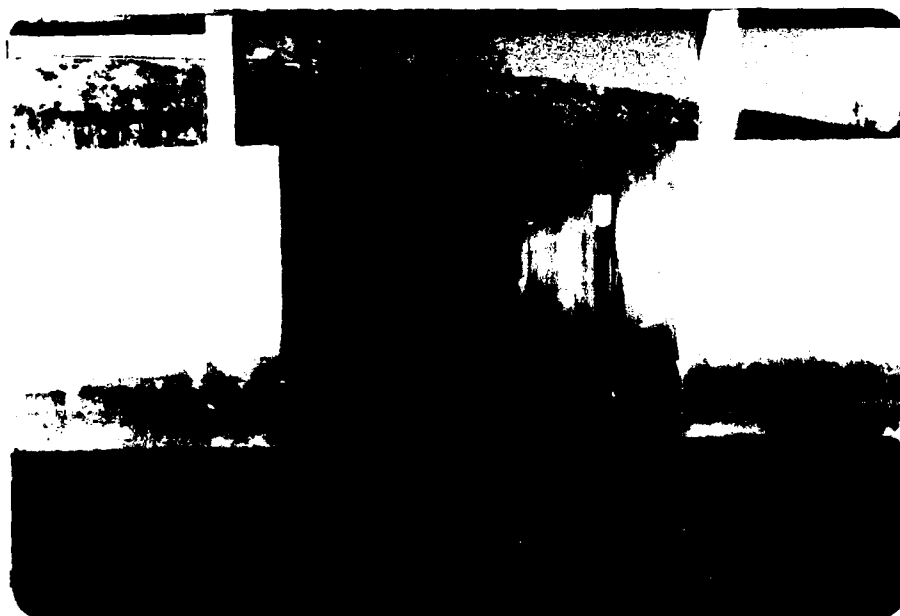
PHOTO NO. 33 - OUTLET OF PRINCIPAL SPILLWAY

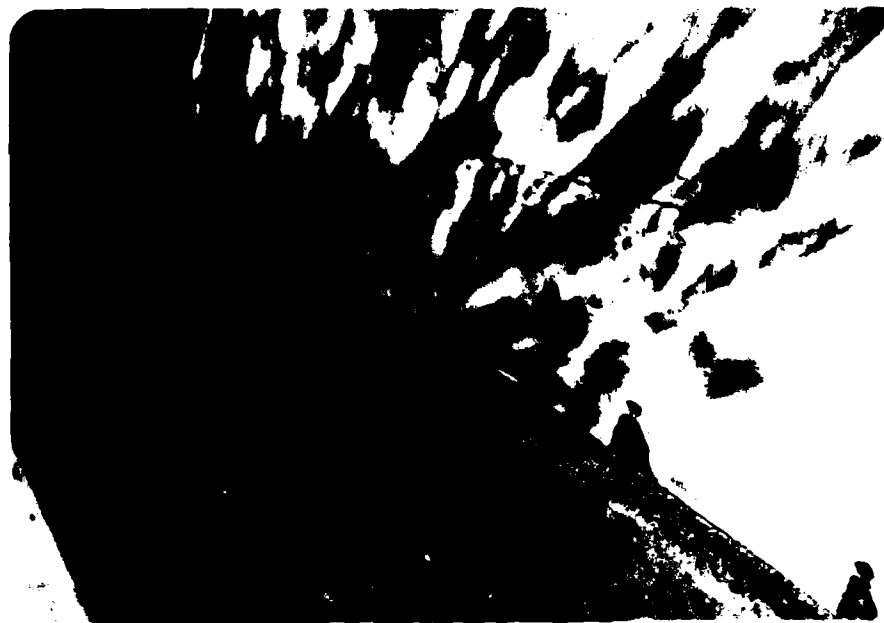
PHOTO NO. 34 - WEEP HOLES IN LEFT WALL OF PRINCIPAL SPILLWAY
OUTLET CHANNEL

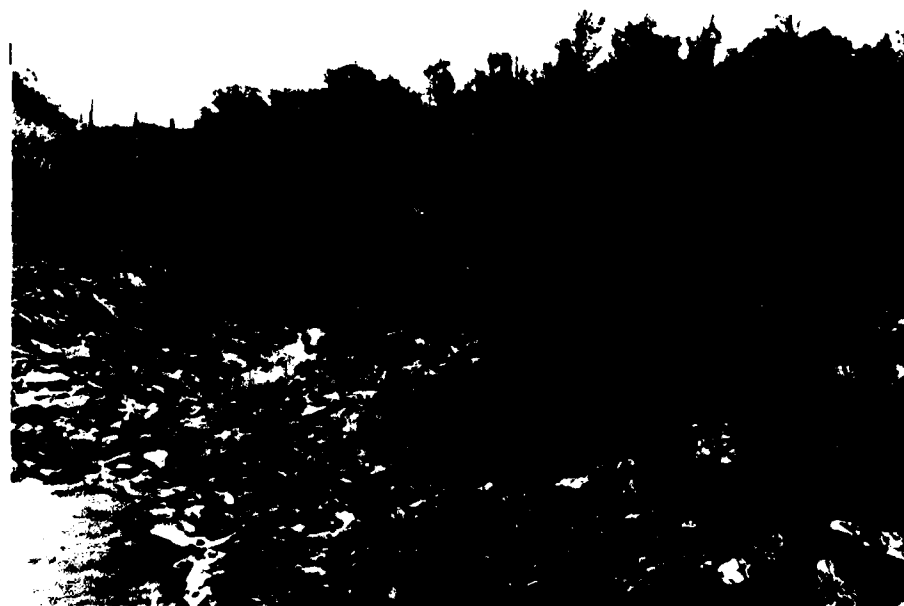
- e. Downstream Channel. The old stream channel has been partially filled and now serves only as an outlet for the toe drain. The two spillways outlet into an excavated channel which is clear of obstructions and pretty well stabilized with rock riprap as shown in Photo No. 35. This channel enters the old North Blackbird Creek channel about 450 feet downstream from the toe of the dam.

PHOTO NO. 35 - LOWER END OF OUTLET CHANNEL FOR PRINCIPAL
SPILLWAY

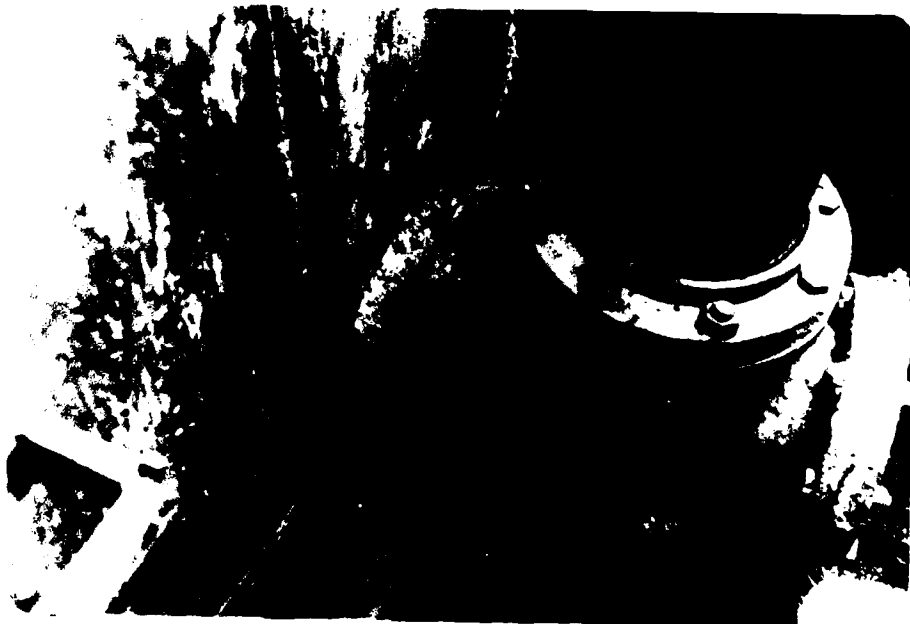
One small rodent hole was observed (Photo No. 21), but others could be present. Measurements of the slope presented on Plate C-31 indicate that it is slightly flatter than the 1V on 3H shown on the plans. There is some indication of wetness in the surface drainage ditch along the upstream edge of the berm as shown in Photo's 20 and 38. However, this wetness on the berm appears to be due to imperfect discharge of surface drainage. There were no indications of erosion, bulges, slips or other deformations on the slope. There were no indications of seepage on the slope or along the toe of the principal embankment. However, there is considerable seepage outcropping around the walls of the sewer lift station located downstream from about station 8+00 and about 100 feet right of the principal spillway outlet structure (S.A.F. basin). Plates C-28, C-29 and C-30 show the location and plans for the lift station which will serve the sewer line passing under the reservoir and dam from the west side of the lake. Photo's Nos. 23, 25, 26, 27, and 28 show the seepage around the lift station. The seepy area is very spongy and semi-bouyant. Seepage discharge from the area, part of which is shown in Photo 26, is estimated at about 1 g.p.m. The sewer line into the lift station is not in use and is capped at its termination in the bottom of the station as shown in Photo No. 39. The floor of the lift station is essentially dry as shown in Photo No. 40.

PHOTO NO. 39 - CONNECTION OF SEWER LINE UNDER DAM WITH
LIFT STATION
